## Stormwater Committee Summary Report and Recommendations

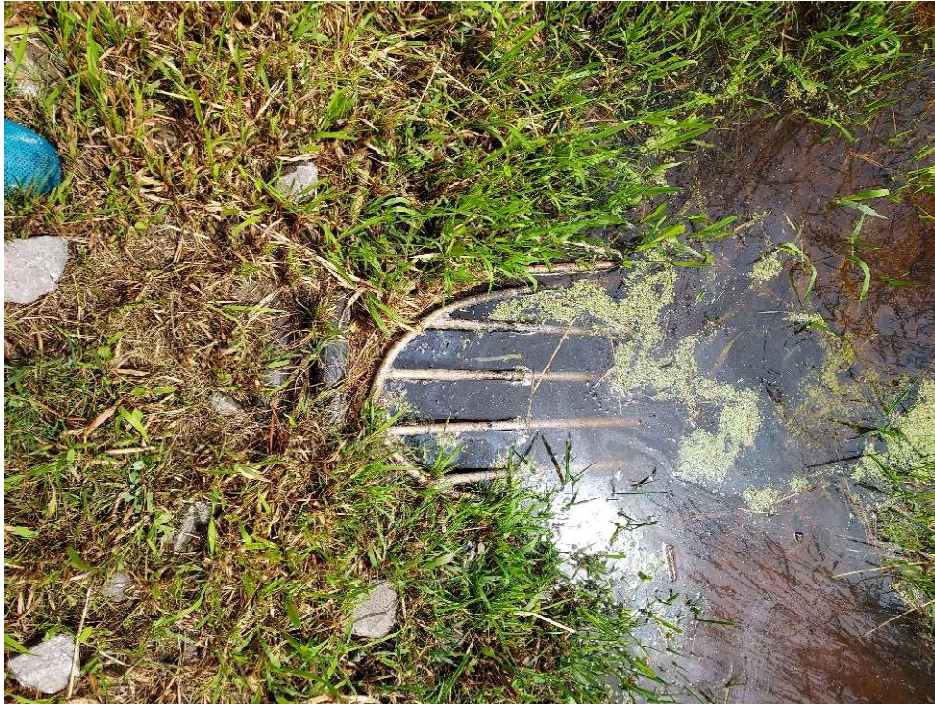
Given the standing water in the culverts, particularly at the outfall to Tract E, the committee determined the drainage path in Tract E should be cleared to determine the reason for the blockage preventing drainage. The current blockage renders the outfall pipes ineffective during high flow events because about half the pipe flow area is ineffective.

Figure 1: Tract D outlet filled with standing water

- 5) The committee recommends the priority should be to mow Tract E along the drainage path to expose the drainage path, identify the blockage and determine corrective actions needed. We can then estimate mitigation costs to correct any issues.

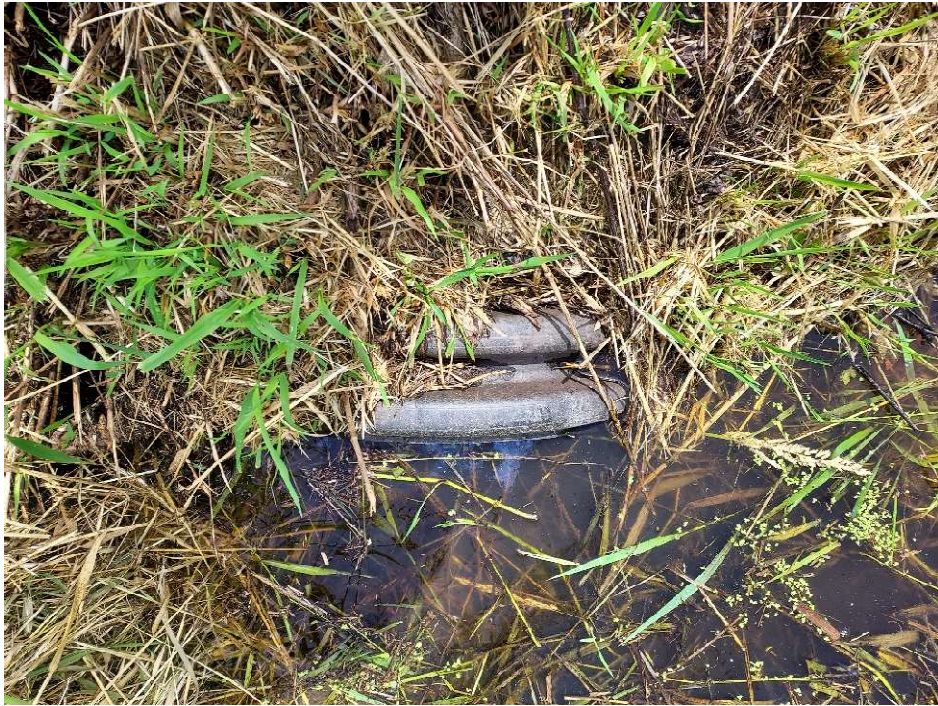
Figure 2: Tract E Inlet with standing water

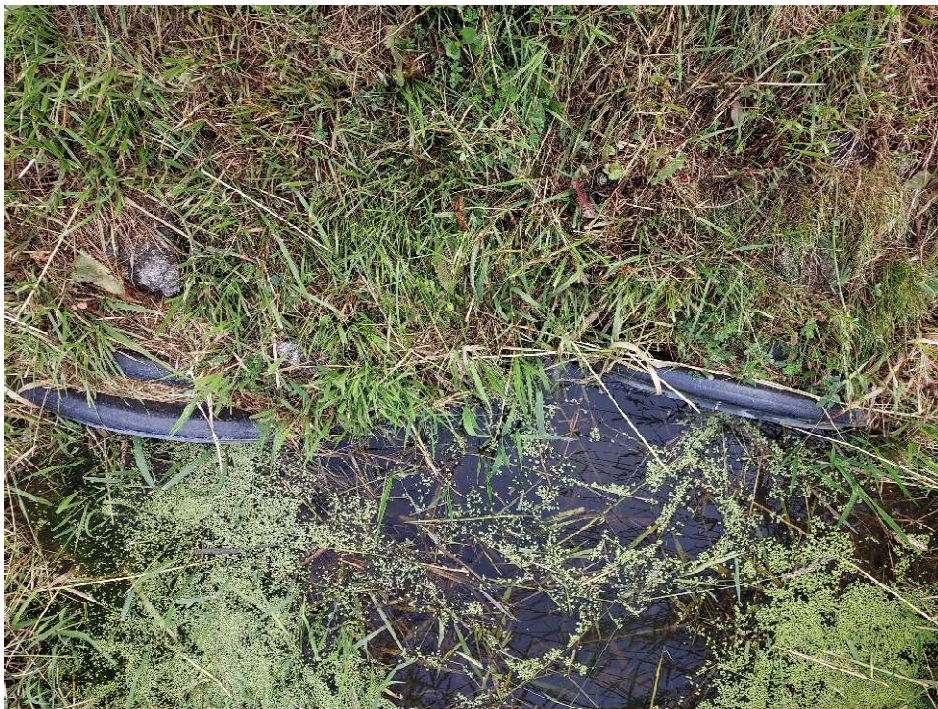
Figure 3: Tract D Inlet with standing water

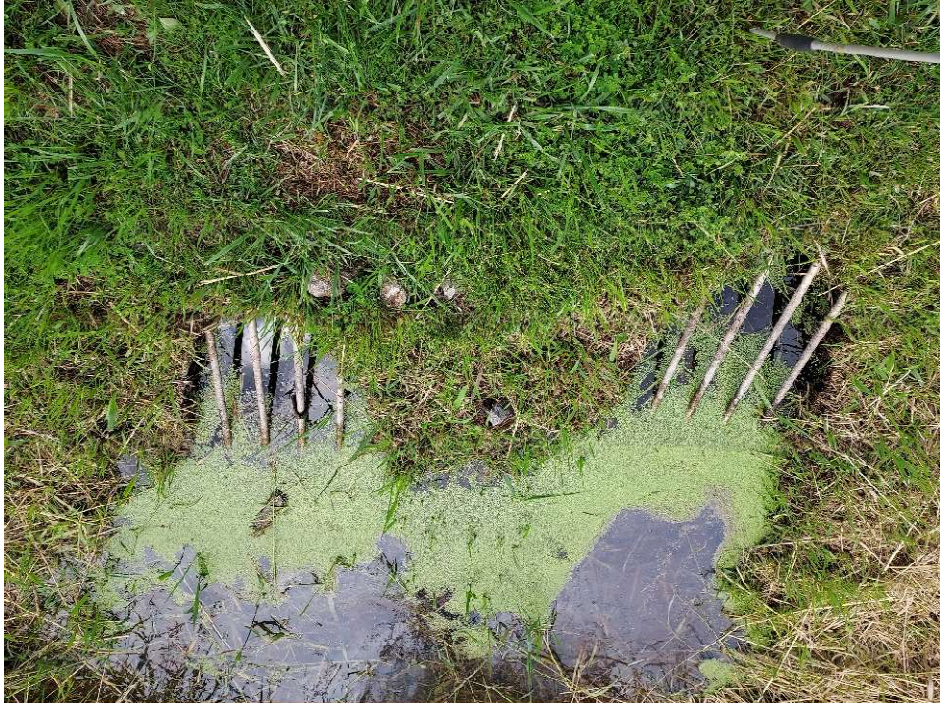
Figure 4: Tract C Outlet with standing water
